AFRL-ML-WP-TP-2006-417

**VIBRATION TESTING OF REPAIRED
LEAD-TIN/LEAD-FREE SOLDER
JOINTS (PREPRINT)**

Vibration Testing of Repaired Lead-Tin/Lead-Free Solder Joints

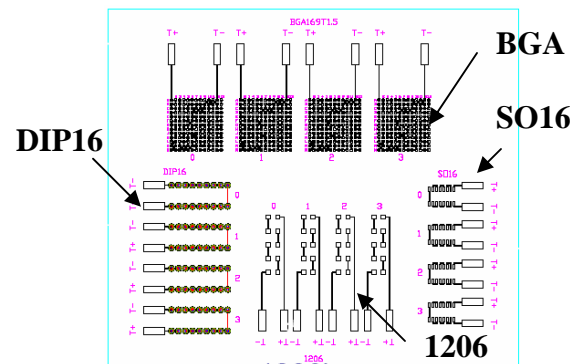
Figure 1: Drawing of PCB that underwent vibration testing.

Three test PCBs, measuring 5in. X 6 in., were tested (Figure 1). The PCBs were made of 10 alternating layers of polyimide and copper. An initial layer of hot air solder level (HASL) finish (63/37 SnPb) was present in all PCBs prior to rework. The PCBs contained ball grid arrays (BGAs), 1206 resistors, SO16 SMT and DIP16 through hole components. Each component was internally daisy chained. The BGA components contained no underfill. The first PCB, or control PCB, contained all Sn63/Pb37 components and was tested in the as manufactured condition. The original components from the second and third PCBs were removed and the pads cleaned with a solder wick. The components were repaired once on the second PCB (R1 for repaired once) and third PCB (MR for multiple repairs). Only the DIP16s were repaired multiple times on the third PCB (MR). The second PCB was selected for scanning electron microscopy (SEM) analysis since it contained different solder combinations (Table 1). Lead-tin (Sn63/Pb37) or LF solder paste (SAC 305 or Sn/3%Ag/0.5%Cu) was applied to select pads on the PCBs. New components containing lead-tinned (Sn63/Pb37) or LF tinned (SAC 305) components were re-flowed and DIP16 components were hand soldered.

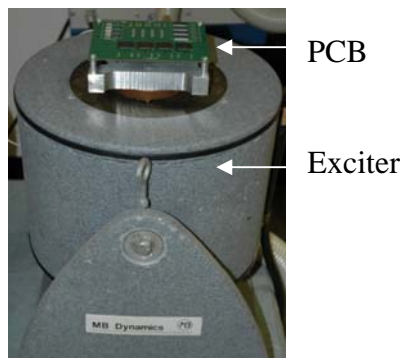
Figure 2: Electrodynamic exciter in vertical position with PCB. Excitation occurs in the transverse direction.

Vibration testing was undertaken with a MB Dynamics MB-250 electrodynamic exciter (Figure 2). Excitation was applied in the transverse axis with the four corners of the PCB held in place by four aluminum stand-offs. An Endevco I-TEDS accelerometer was placed on the geometric center of the Al base and served as the control accelerometer. An Endevco PE-22 piezoelectric accelerometer that weighed 0.14 grams was placed on the geometric center of the PCB and served as the response accelerometer.

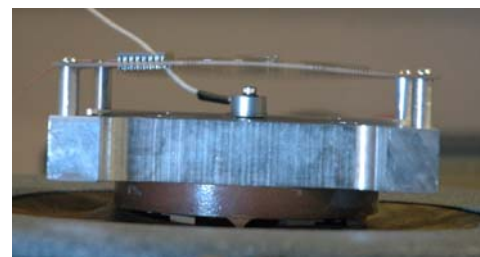
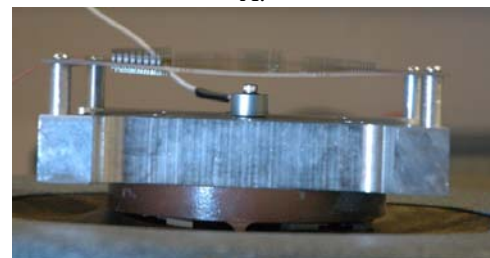
Figure 3: PCB at first mode of vibration. The resonant frequency is ~167Hz.

Within the first five minutes of vibration testing, the interconnect resistance for the BGAs and 1206 components and PCB resonant frequency were affected. The initial frequency sweeps showed that the average resonant frequency of the PCBs was ~167Hz. At the first mode, flexure was observed on the middle of the PCBs (Figure 3). Within 25 seconds of starting the resonance dwell, the flexure amplitude was observed to drop to about 50-66% of its initial level. After a 30 minute cumulative resonance dwell, the average resonant frequency dropped to ~160Hz.

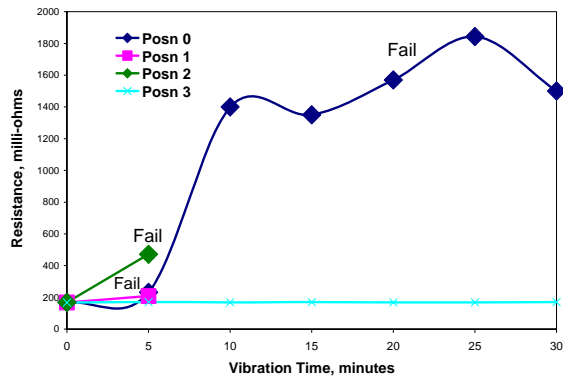
A. Control PCB – All Pb-Sn solder joints

Figure 4: Interconnect Resistance for 1206 components during a resonance dwell test. Bold symbols represent open circuit.

Opens were detected on the BGAs after the first five minutes of the resonance dwell. The BGAs were the first component to fail. This resulted in a drop in PCB resonant frequency, which was most likely caused by an overall drop in board stiffness. Failures or interconnect opens for the 1206 components were more likely to occur for the center components or positions 0, 1 and 2 (Figure 4 and Figure 1). Optical images for the failed 1206 components showed cracking in the bulk solder or delamination of the component from the solder (Figure 5).

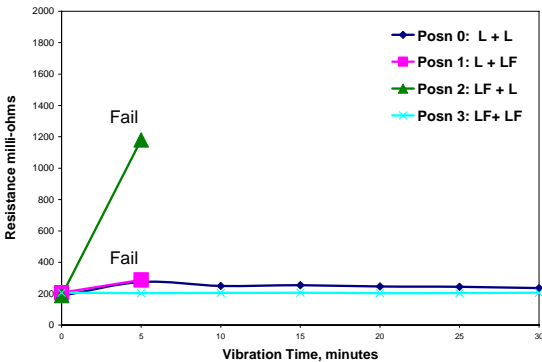
B. PCB R1 – L= Pb-Sn, LF = lead-free solder

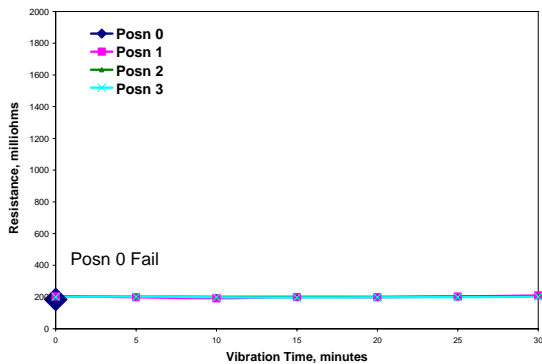
C. PCB MR – All LF solder joints, except 0 (Pb-Sn)

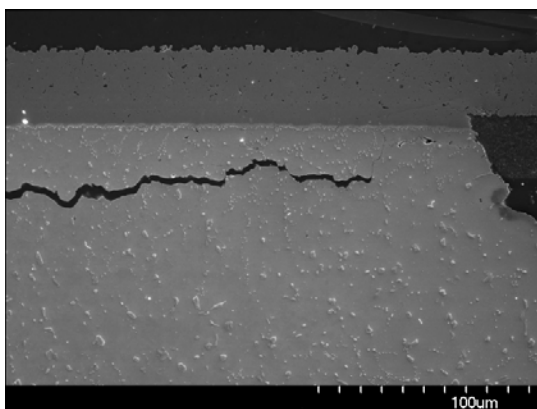
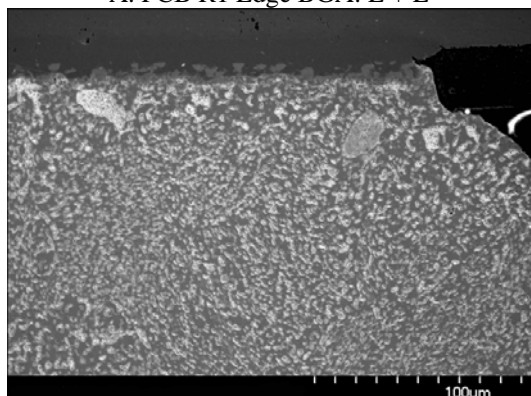
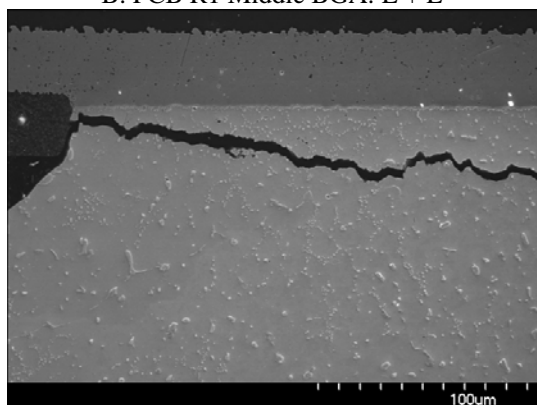
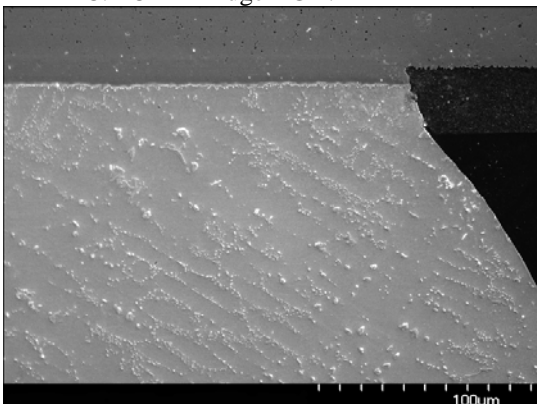
A. PCB R1 Edge BGA: L + L

B. PCB R1 Middle BGA: L + L

C. PCB R1 Edge BGA: LF + LF

D. PCB R1 Middle BGA: LF + LF

Figure 7: SEM images (500X) of BGAs where the solder mask was applied. First letter corresponds to type of solder paste on pad and the second to solder type on the component.

Edge balls or balls adjacent to the edge or corners of the BGA were likely to fail by cracking while the middle solder joints remained intact (Figure 6). This trend was observed for all BGAs regardless of solder type (Figures 7 and 8). The crack started at the region of the solder ball where the solder mask is applied. This region corresponds to the smallest diameter of the ball. The crack started on the outside and traveled into the solder bulk. This behavior was not always consistent since it was also possible for the crack to propagate into the intermetallic layer formed between the solder and the component pad (Figure 8A). The damaged was caused by higher tensile and compressive stresses experienced by the edges and corners of a BGA component as the PCB deflects during the first mode of vibration (Figure 9).

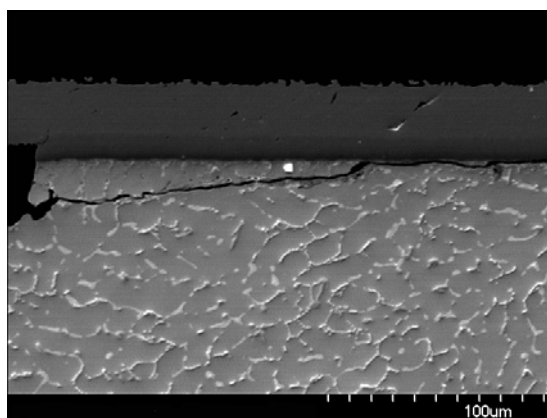
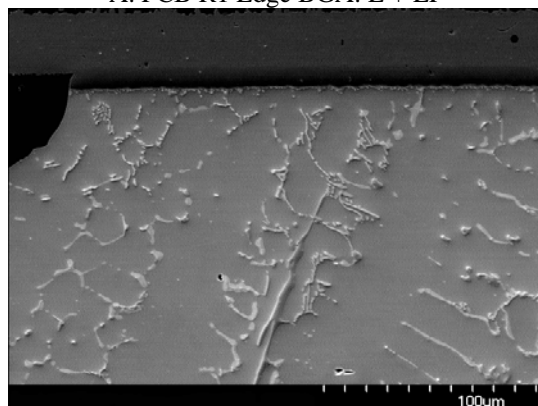
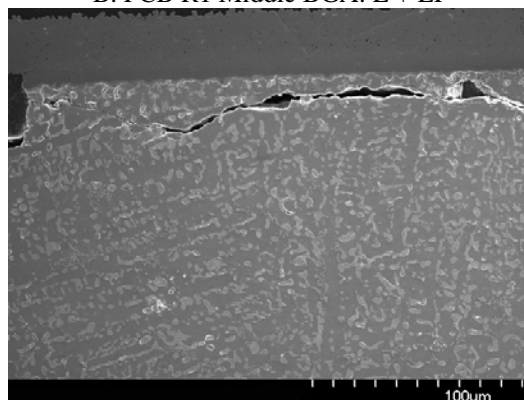
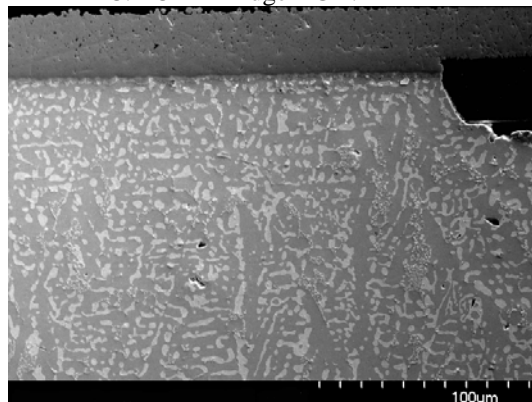
A. PCB R1 Edge BGA: L + LF

B. PCB R1 Middle BGA: L + LF

C. PCB R1 Edge BGA: LF + L

D. PCB R1 Middle BGA: LF + L

Figure 8: SEM images (500X) of BGAs where the solder mask was applied. First letter corresponds to type of solder paste on pad and the second to solder type on the component.
